Causes and Effects of the Rapid Sinking of the Titanic

Prepared for
Teacher's Name
University of Wisconsin

Vicki Bassett
College of Engineering
University of Wisconsin

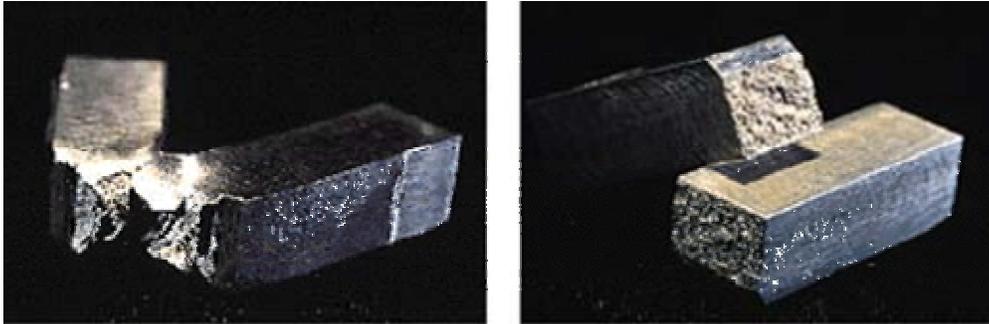
When the coupon of the modern steel was tested, the pendulum swung down and halted with a thud; the test piece had bent into a "V." However, when the coupon of the Titanic steel was tested, the pendulum struck the coupon with a sharp "ping," barely slowed, and continued up on its swing; the sample, broken into two pieces, sailed across the room [Gannon, 1995]. Pictures of the two coupons following the Charpy test are shown in Figure 1. What the test showed, and the readout confirmed, is the brittleness of the Titanic's hull steel. When the Titanic struck the iceberg, the hull plates did not deform. They fractured.

Figure 1. Results of the Charpy test for modern steel and Titanic steel [Gannon, 1995]. When a pendulum struck the modern steel, on the left, with a large force, the sample bent without breaking into pieces; it was ductile. Under the same impact loading, the Titanic steel, on the right, was extremely brittle; it broke in two pieces with little deformation.

A microstructural analysis of the Titanic steel also showed the plausibility of brittle fracture of the hull steel. The test showed high levels of both oxygen and sulphur, which implies that the steel was semi-killed low carbon steel, made using the open-hearth process. High oxygen content leads to an increased ductile-to-brittle transition temperature, which was determined as 25 to 35°C for the Titanic steel.

Most modern steels would need to be chilled below -60°C before they exhibited similar behavior. High sulphur content increases the brittleness of steel by disrupting the grain structure. The sulphur combines with magnesium in the steel to form stringers of magnesium sulphide, which act as "highways" for crack propagation. Although most of the steel used for shipbuilding in the early 1900s had a relatively high sulphur content, the Titanic's steel was high even for the times [Hill, 1996].

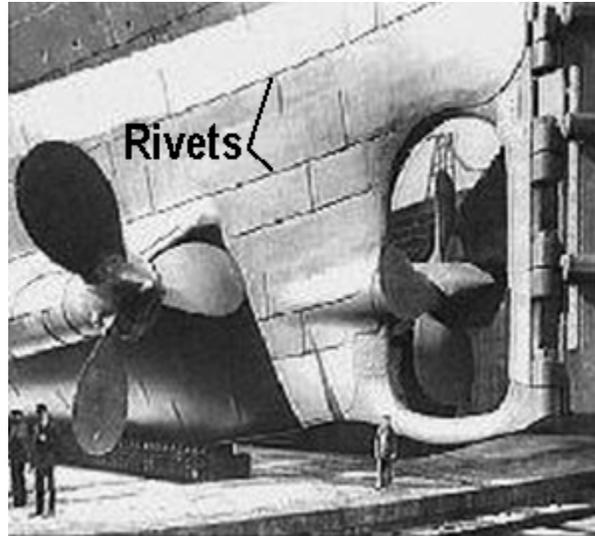
The Rivets. The wrought iron rivets that fastened the hull plates to the Titanic's main structure also failed because of brittle fracture from the high impact loading of the collision with the iceberg and the low temperature water on the night of the disaster. Figure 2 shows the Titanic during her construction, with the riveted hull plates of her stern visible. With the ship traveling at nearly 25 mph, the contact with the iceberg was probably a series of impacts that caused the rivets to fail either in shear or by elongation [Garzke and others, 1994].

As the iceberg scraped along sections of the Titanic's hull, the rivets were sheared off, which opened up riveted seams. Also, because of the tremendous forces created on

impact with the iceberg, the rivet heads in the areas of contact were simply popped off, which caused more seams to open up. Normally, the rivets would have deformed before failing because of their ductility, but with water temperatures below freezing, the rivets had become extremely brittle.

Figure 2. The Titanic in the shipyard during her construction [Refrigerator, 1998]. Note the hull plates, fastened on all sides to the ship's main structure by thousands of rivets.

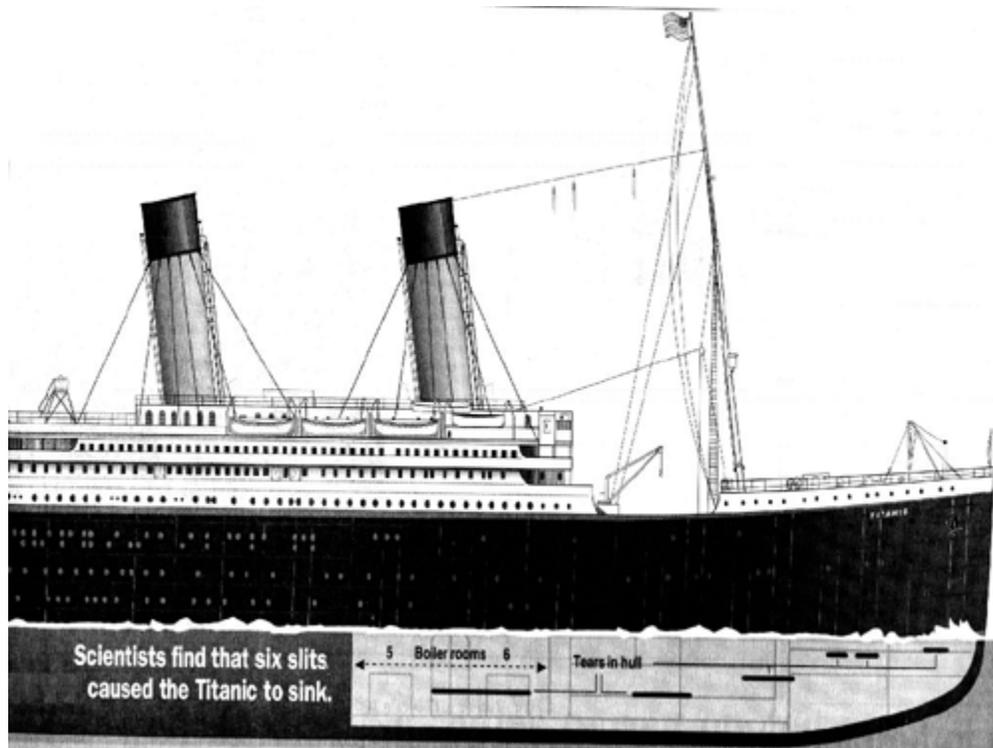
Along with the material failures, poor design of the watertight compartments in the Titanic's lower section was a factor in the disaster. The lower section of the Titanic was divided into sixteen major watertight compartments that could easily be sealed off if part of the hull was punctured and leaking water. After the collision with the iceberg, the hull portion of six of these sixteen compartments was damaged, as shown in Figure 3. Sealing off the compartments was completed immediately after the damage was realized, but as the bow of the ship began to pitch forward from the weight of the water in that area of the ship, the water in some of the compartments began to spill over into adjacent compartments.

Although the compartments were called watertight, they were actually only watertight horizontally; their tops were open and the walls extended only a few feet above the

waterline [Hill, 1996]. If the transverse bulkheads (the walls of the watertight compartments that are positioned across the width of the ship) had been a few feet taller, the water would have been better contained within the damaged compartments. Consequently, the sinking would have been slowed, possibly allowing enough time for nearby ships to help. However, because of the extensive flooding of the bow compartments and the subsequent flooding of the entire ship, the Titanic was gradually pulled below the waterline.

Figure 3. A layout of the watertight compartments and the damage from the collision [Refrigerator, 1998]. The thick black lines below the waterline indicate the approximate locations of the damage to the hull.

The watertight compartments were useless to countering the damage done by the collision with the iceberg. Some of the scientists studying the disaster have even concluded that the watertight compartments contributed to the disaster by keeping the flood waters in the bow of the ship.

The ends of the transverse bulkheads of the watertight compartments were raised to prevent a tragedy similar to the Titanic. When the hull of the Titanic was torn open in the collision with the iceberg, water began to flood the damaged compartments in the bow. As the ship pitched forward under the weight of the water in the bow compartments, water began to spill over the tops of the bulkheads into adjacent, undamaged compartments.

Although called watertight, the watertight compartments were actually only watertight horizontally; their tops were open and the walls extended only a few feet above the waterline. By raising the ends of the transverse bulkheads, if a ship were taking in water through the bow compartments and the ship began to pitch forward, the water in the compartments could not flow over the tops of the bulkheads into the next compartments. As a result, flooding of the damaged compartments could be controlled and isolated to only the damaged sections [Gannon, 1995].

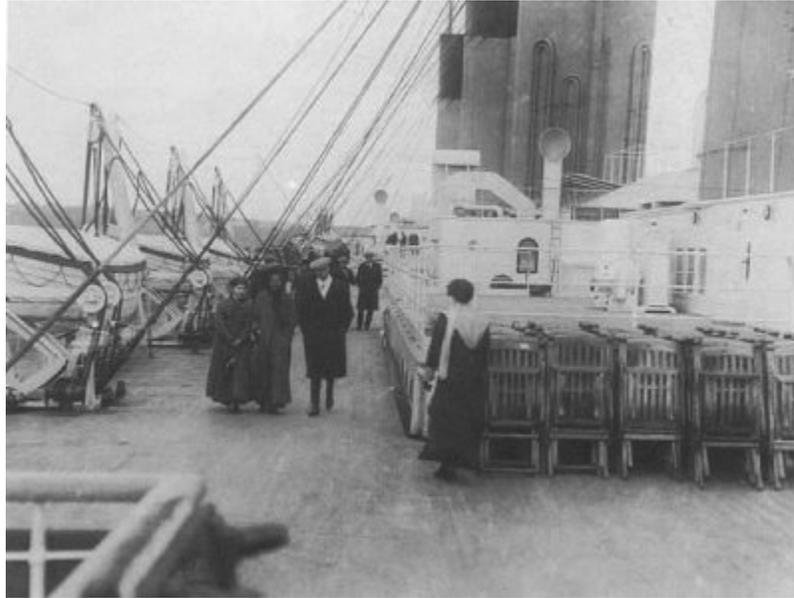
Although there was room on deck for twice as many lifeboats, the Titanic carried lifeboats for just over half of the passengers and crew on board. The designer of the Titanic had allowed room on deck for two rows of lifeboats, but one row was removed before the voyage began to make the deck more aesthetically pleasing [Rogers and others, 1998]. With outdated British Board of Trade regulations, the Titanic's twenty lifeboats actually exceeded requirements by 10 percent capacity [Refrigerator, 1998].

Figure 4 shows the davits and lifeboats on the deck of the Titanic. If the minimum lifeboat capacity is not met, additional lifeboats must be stowed under other boats. Regulations also specify that each of the lifeboats must carry oars, sails, a compass,

Figure 4. The deck of the Titanic [Refrigerator, 1998]. The davits and lifeboats are on the left. The people are walking through the extra space on the deck that was designed to hold the additional lifeboats.

The new safety regulations increased the required number of lifeboats to a number that would accommodate all passengers and crew aboard the ship. Based on the length of the ship, a given number of davits, which are the mechanism used to raise and lower the lifeboats, are mounted along the perimeter of the lower deck.
